RAILROAD ACCIDENT INVESTIGATION

Report No 3843

GREAT NORTHERN RAILWAY COMPANY

APRIL 3, 1959

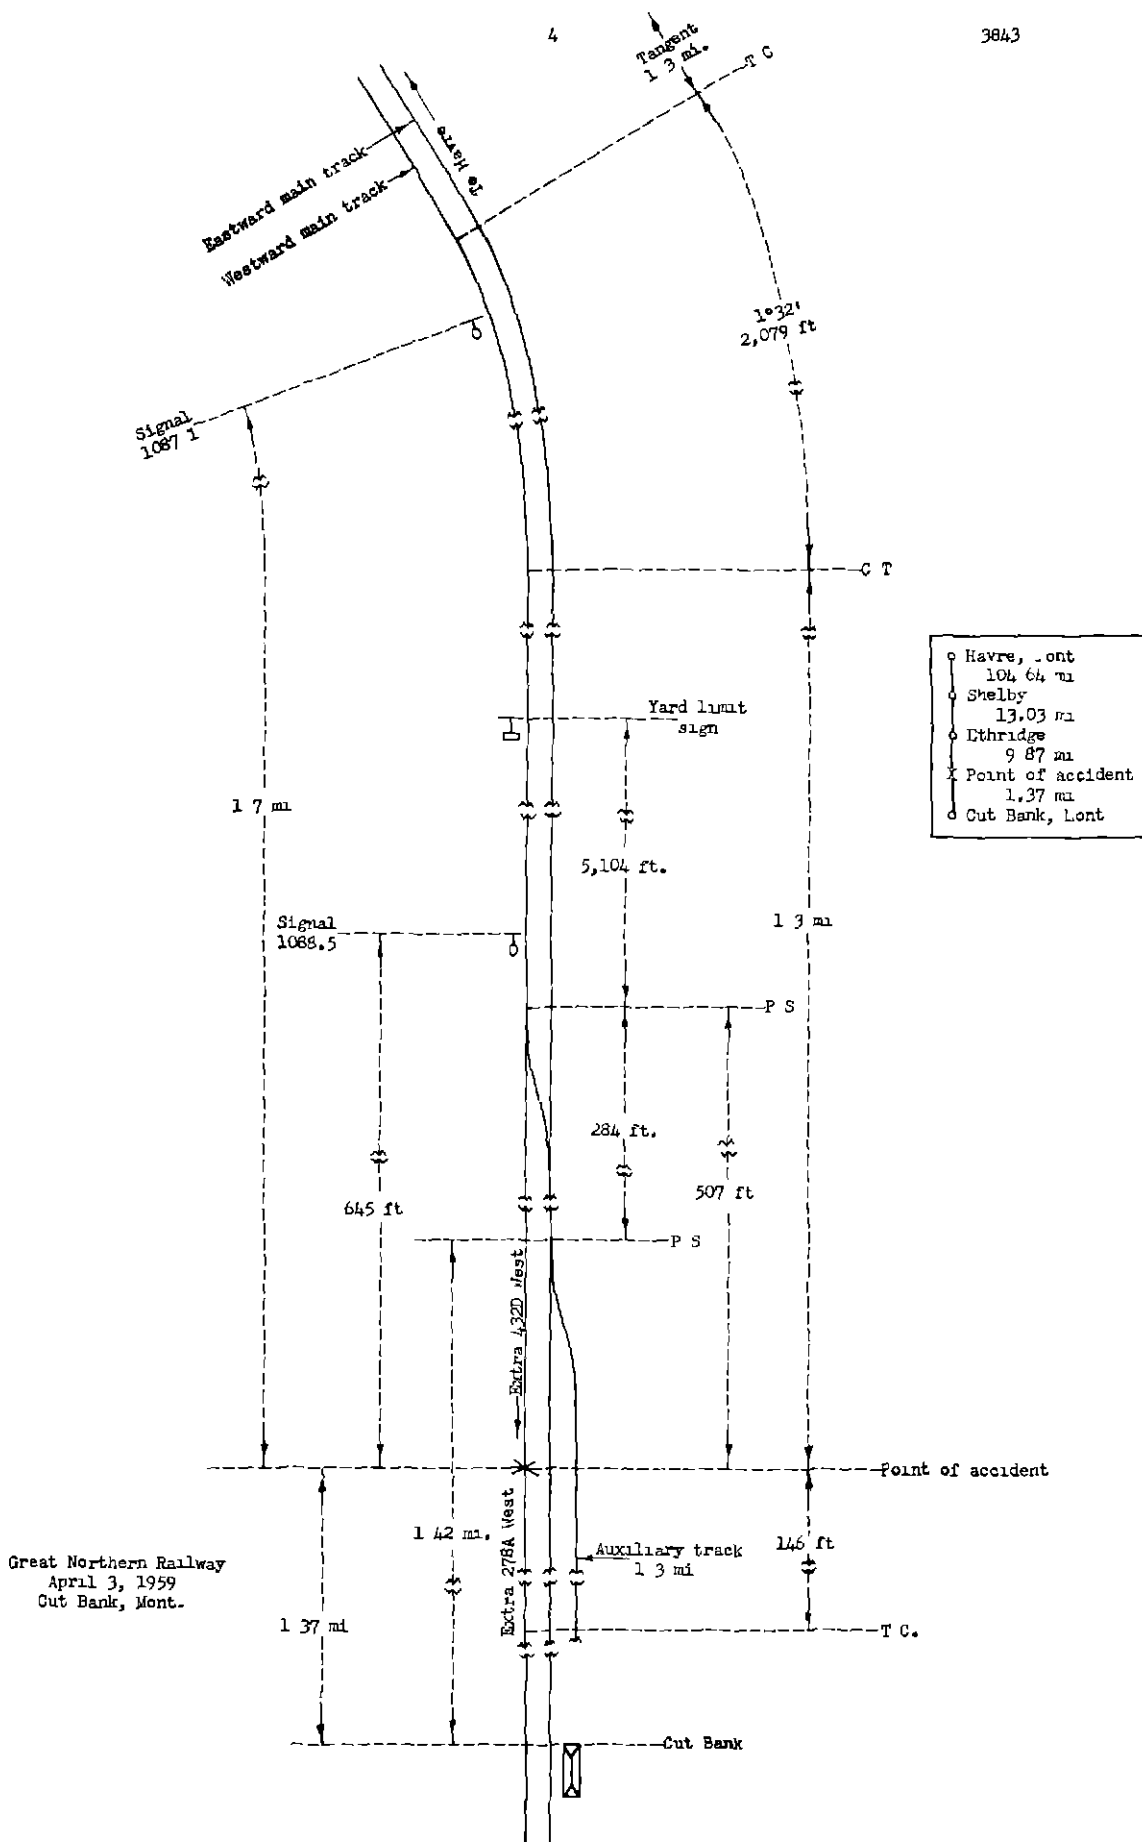
Extra 432D West stopped with the locomotive about 295 feet west of the point of accident. The four diesel-electric units and the first 23 cars were derailed. The diesel-electric units stopped in positions as shown in Plate 1, and the derailed cars stopped in various positions on or near the track structure. The four diesel-electric units were heavily damaged. Sixteen of the derailed cars were destroyed and six were heavily damaged.
